Tree Inventory and Assessment Acton Branch Library Replacement Acton, Ontario

August 2009

Prepared For:
*Halton Hills Public Library
9 Church Street
Georgetown, Ontario
L7G 2A3*

Prepared By:
North-South Environmental Inc.
35 Crawford Crescent, Suite U5
P.O. Box 518
Campbellville, ON
L0P 1B0

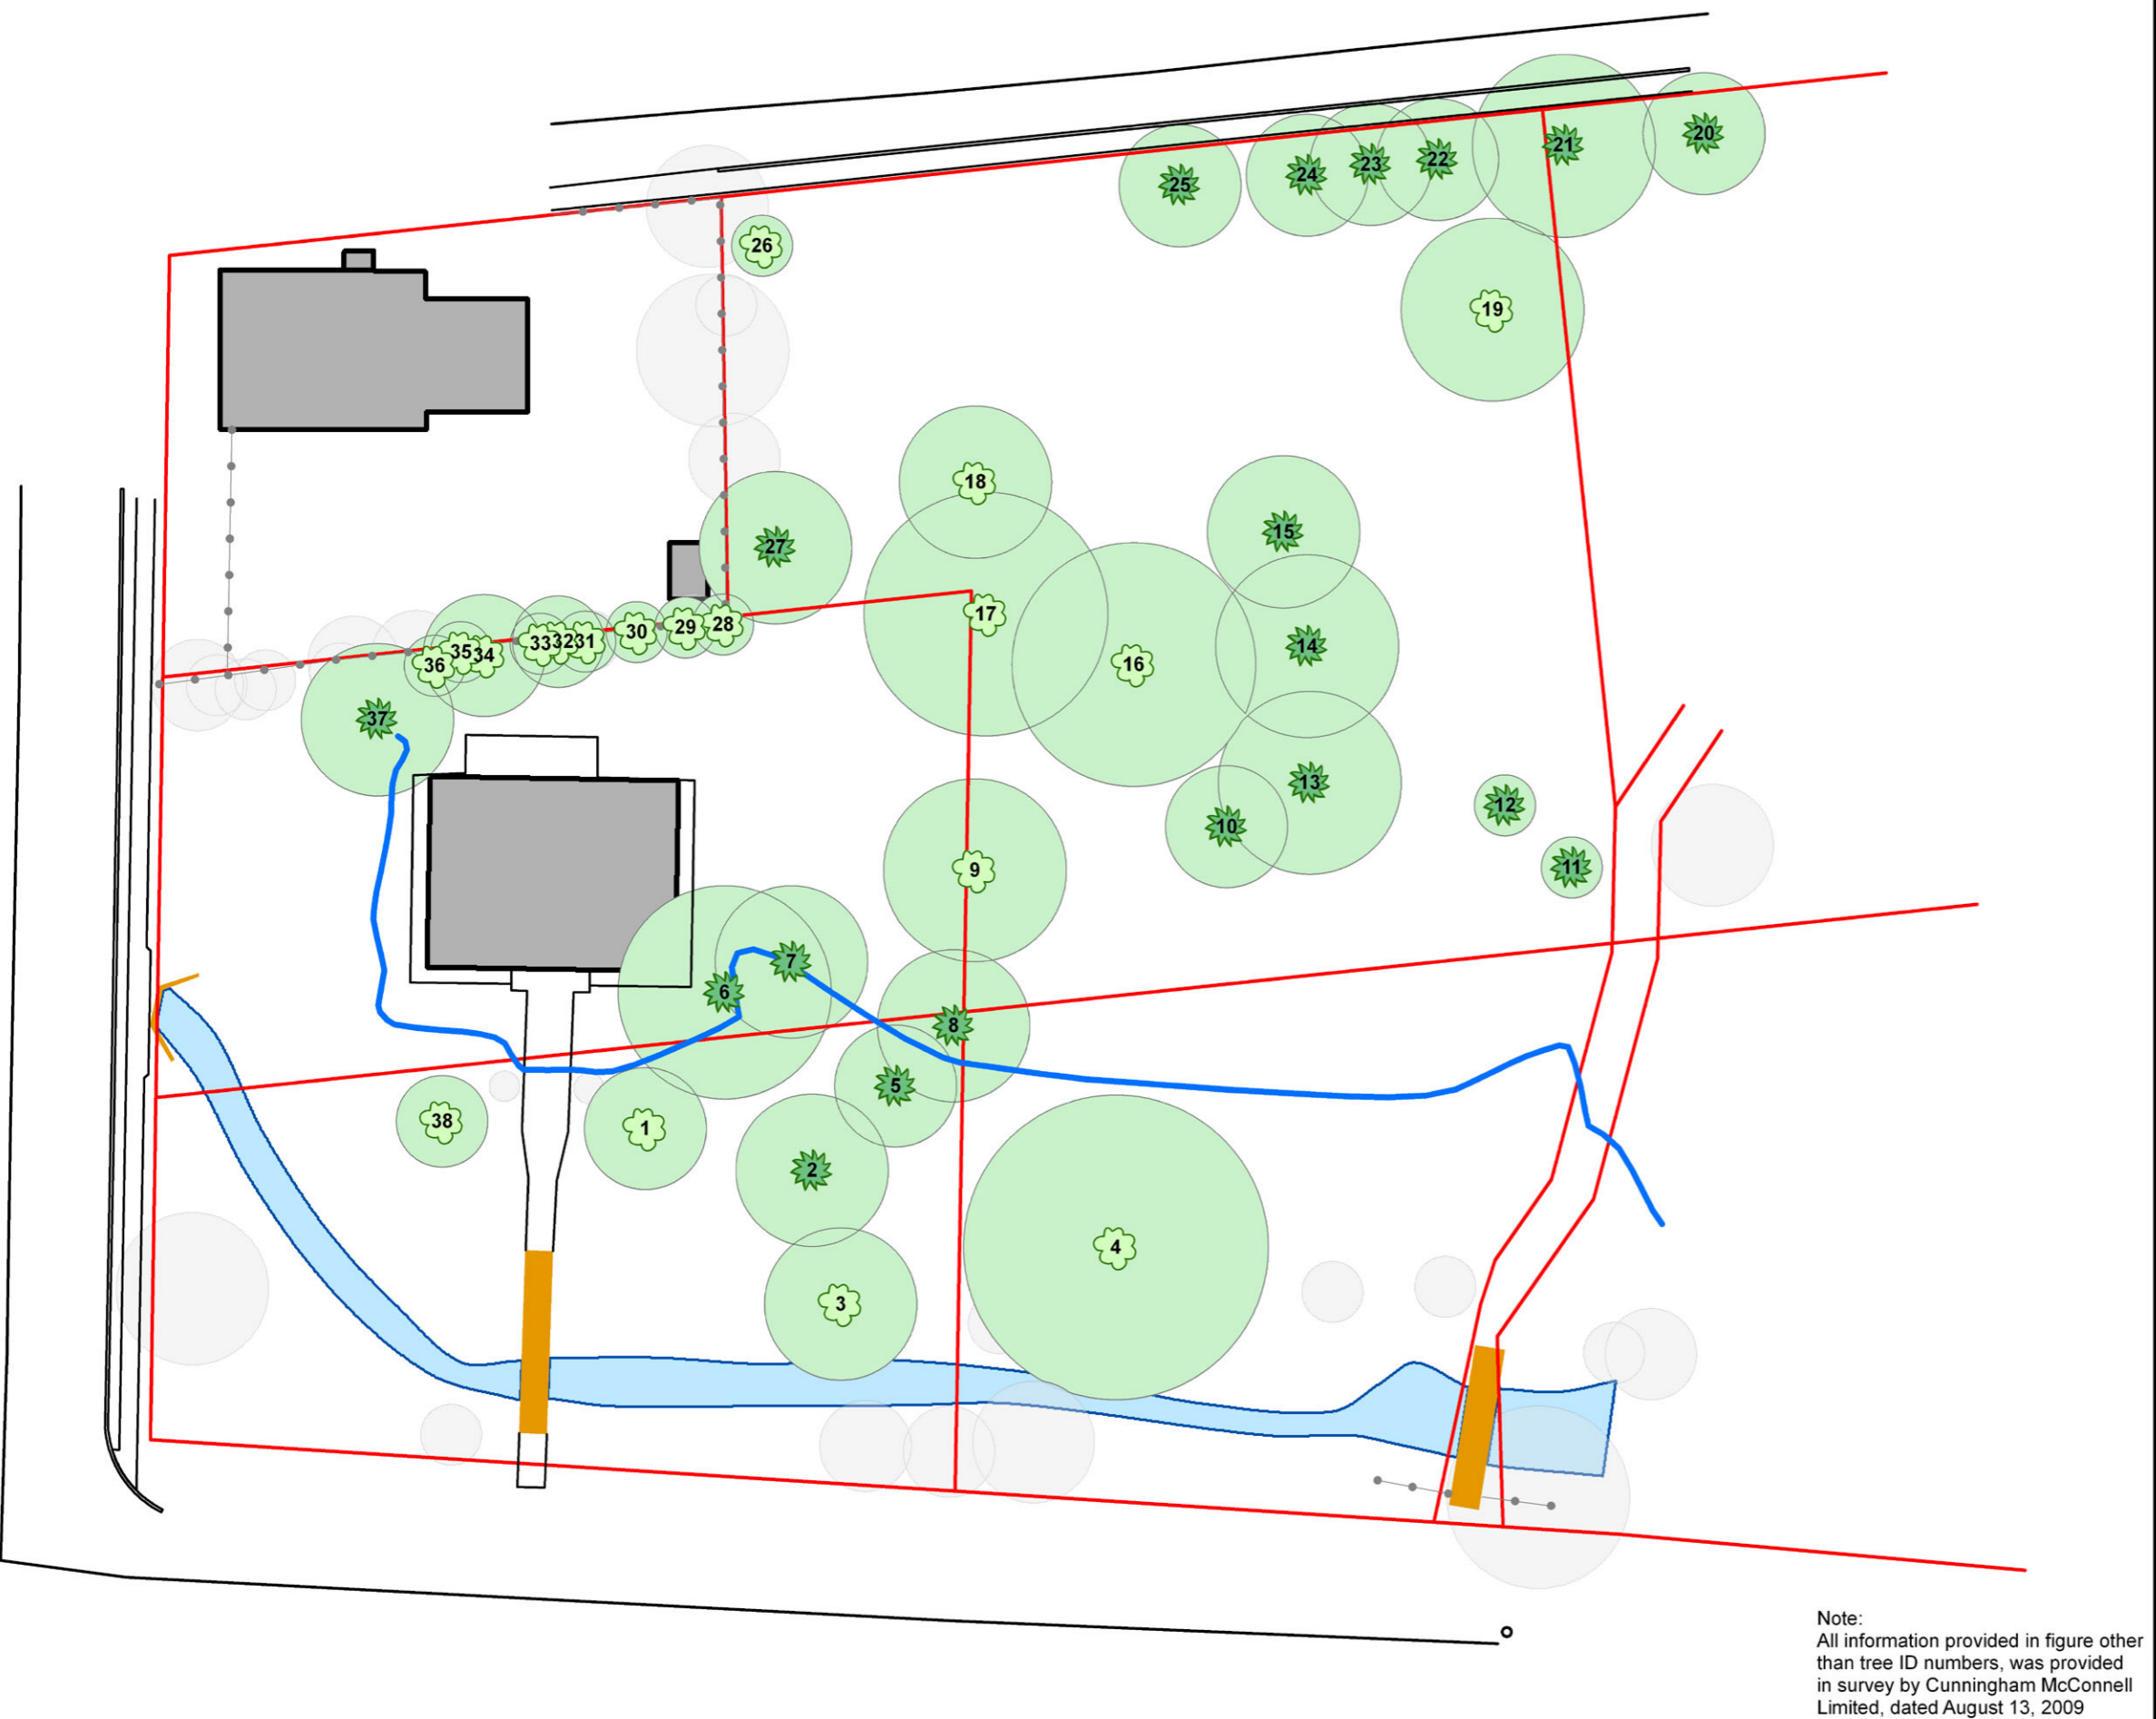
Figure 1

Tree inventory data were correlated with an existing survey, completed by Cunningham McConnell Limited, which provided precise tree locations and canopy widths within the subject property (Figure 1).

Trees numbered 29 and 34 are dead and have been identified as hazard trees. Both of these trees are defoliated and appear to have been dead for some time. Trees 12 and 27 showed evidence of insect borer activity, however, these trees currently remain in relatively good health. Many of the larger Scots pine and Norway spruce have broken tops, most likely due to wind damage (*i.e.*, trees 5, 6, 8, 15, 25, and 27). Although the canopy structure of these trees has been altered, their health largely remains intact. It is noteworthy that Scots pine are susceptible to blowdowns when maturity is reached. Given the unpredictable nature of the stability of these trees, it may be prudent to consider their removal when identifying hazard trees.

Prior to the commencement of construction, it is recommended that all trees identified as hazards be removed from the study area. Depending on the location of the proposed development, further tree removal will most likely be necessary, due to the location of the new library building envelope and the potential need for grade changes. Trees are typically recommended for removal in areas where grade changes exceed ± 0.5 m due to the exposure or smothering of root systems. Trees undergoing less than a ± 0.5 m grade change may be retained if in a healthy condition, but may require special attention such as the creation of a well around the base of the trunk to minimize impacts to root systems. Further investigation into tree preservation can be undertaken once a site plan and grading plan are available. These plans will facilitate identification of trees that will need to be removed and those that can be preserved.
